Title: SOL Petroleum Cayman Limited Tank Incident Investigation Report  
Jackson Point Terminal (JPT)  
South Sound, George Town  
Cayman Islands

Document No: OF-IR-001/17

## SOL DIESEL FUEL TANK INCIDENT INVESTIGATION REPORT

Incident Description: Diesel Tank No. 8 Internal Fire

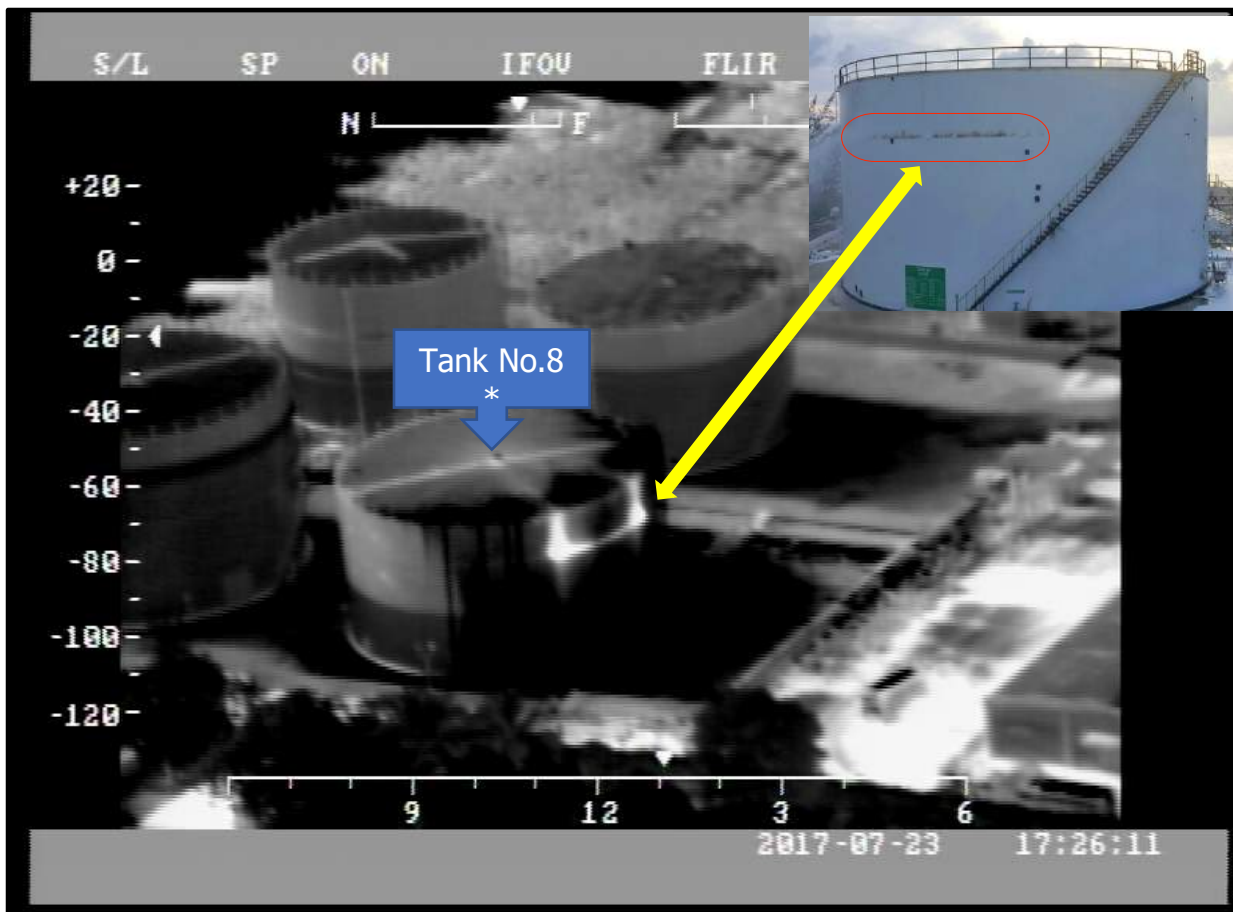
Photo Showing Aerial Image of Heat Source Inside Tank # 8 Courtesy of RCIPS Air Support Unit. Inset shows the Scorching as Observed on Tank No. 8.

On conclusion of day 2 activities, the Welder, upon closing off his activities for the day, observed the paint on the upper portion of the tank shell was scorching and partially discoloured, consistent with the effect of a reaction. A source of heat inside the tank was heating the metal in that area causing the paint coating to smoulder as a consequence. J&R personnel who were the only persons on site at time alerted the SOL site representative, who was not on site at the time the incident was discovered. SOL's Site Emergency Procedure is essentially as follow:

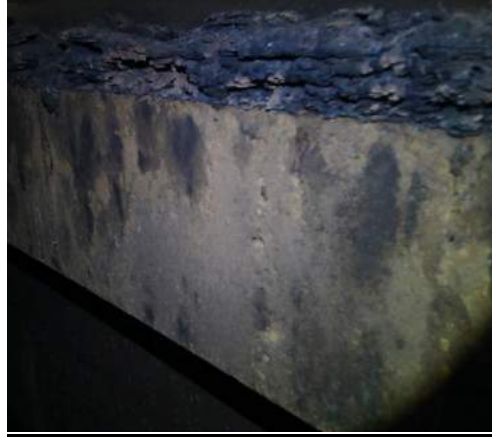
Photo #2 - Corrosion Material Build-Up on Upper Reinforcement Ring

The liquid level in the tank at the time of incident was approximately 15 feet from the bottom of the tank while the fire occurred at a height of 30 feet from the bottom. Based on this, the investigation considers that the most likely source of ignition would have been droplet(s) of molten metal from the steel roof plate as illustrated in the photographs referenced above, which came into contact with the likely warm fuel on the upper reinforcement ring leading to the fire.

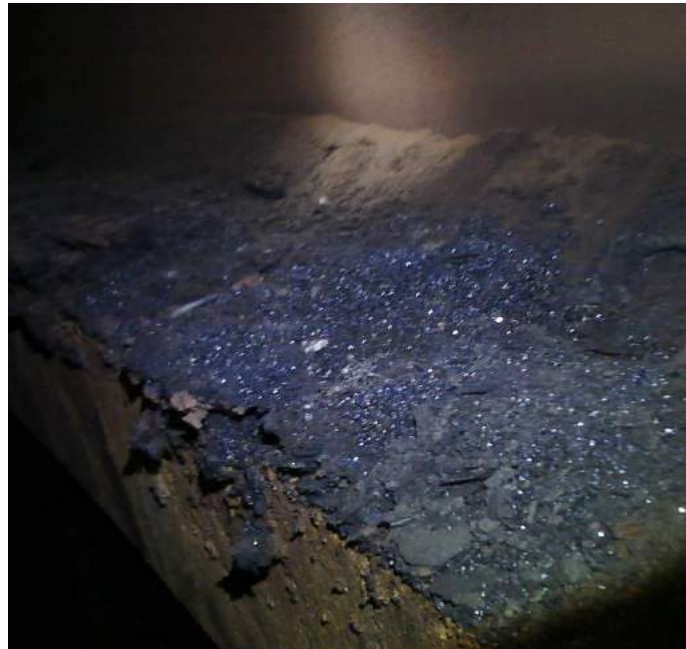
*During the internal tank inspection carried out on 14 November 2017 as part of the investigation, photographic evidence revealed an area of burn-through on the steel roof plate (see Photo #1 below) directly above the location of interest where the fire started, and evidence of external smouldering was observed. In addition, the upper reinforcement ring of the tank was found to have approximately a one (1) inch thick deposit of loose corrosion material layered with a slag-like substance consistent with a material which was exposed to heat (see Photo #2). The build-up and materials found in this area still contained diesel residue, and was distinguishable from the other areas sampled in that a mix of sandblasting and welding residue, along with a noticeable metal bead were also found on the top of the build-up. (see Photo #3).*

Photo #3 – Sandblasting/Welding Residue and Metal Bead.

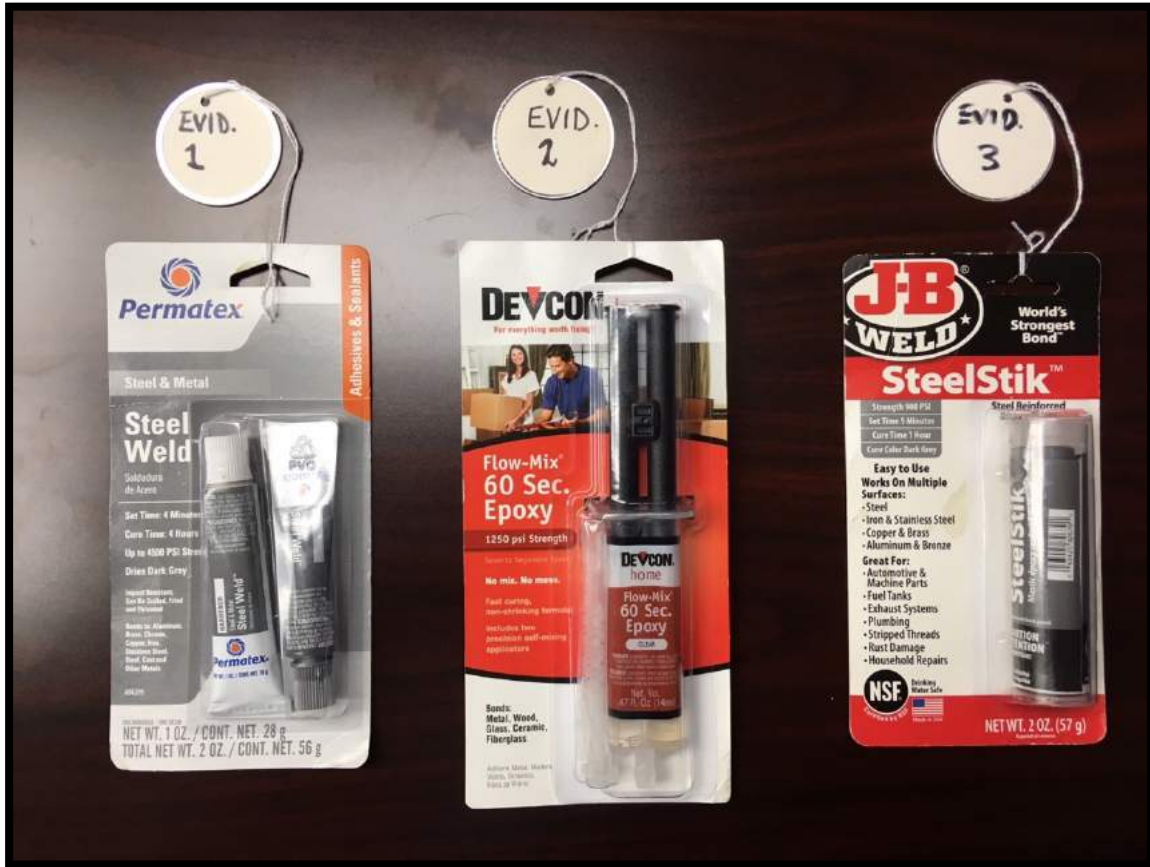
## Appendix 6B.1: Photographic Exhibits of Epoxies

The epoxy putties used were not mentioned in any of the documentation prepared for the execution of the task. Further investigation revealed that the epoxy putties used were not considered suitable to be exposed to welding or environment with elevated temperatures. The Safety Data Sheets (SDS) for the epoxy liquid also states, "Excessive heat" is one of the conditions to avoid when using this product. Under the "Physical and Chemical Properties" stated on the SDS, it is outlined that the epoxy is flammable in the presence of the following conditions: open flames, sparks and static discharge.

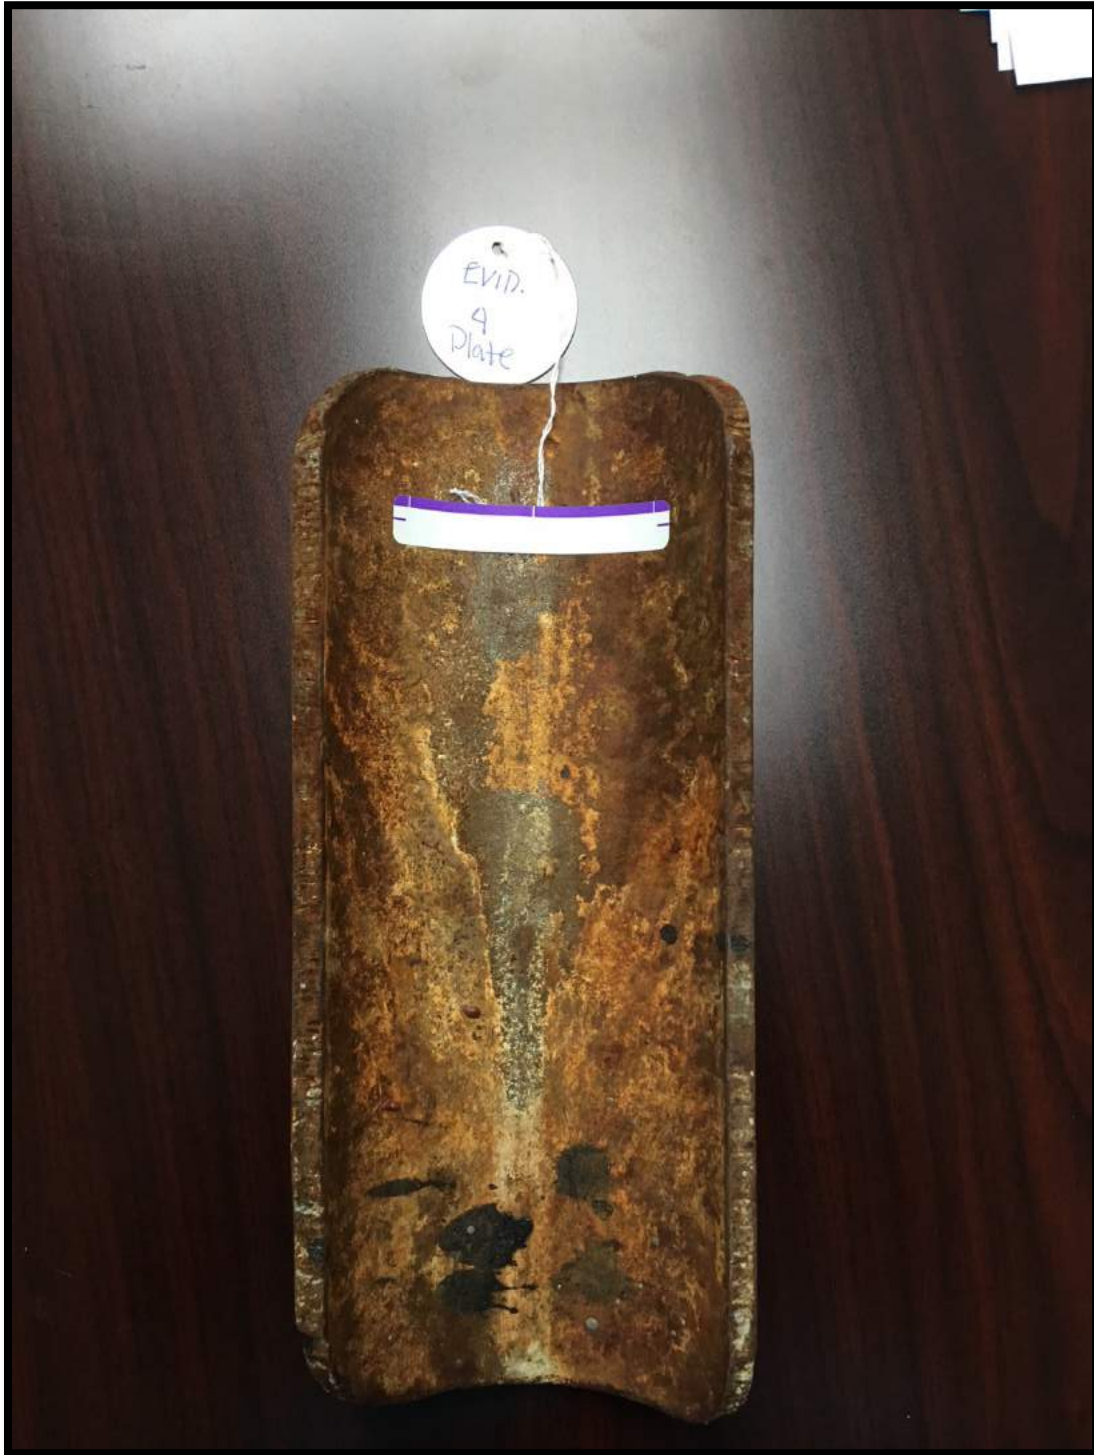
**Appendix 6B.2: Photographic Exhibits of Mild Steel Plate (Patches)**

API 653 specifies a minimum size of metal plates (typically 5mm x 305mm x 305mm) to be used as patches to effect such repairs, as well as the acceptable types of welding to be used based on the circumstances. SOL appeared to have complied with the foregoing for most of the patches installed in this instance, but other pre-existing patches showed inconsistencies.
